Manhole Inspection Summary

Manhole # S04II2018MH

Insp Date: **7/19/06 7:58 AM**

Location Address: **3228 SHELBURNE RD**

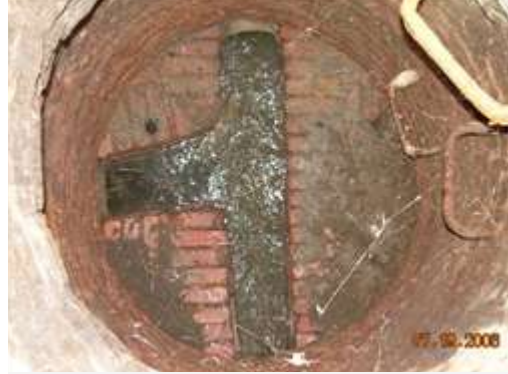
Top View

Adjustment and Corbel infiltration.
Corroded steps. Evidence of surcharge -
Bench debris.

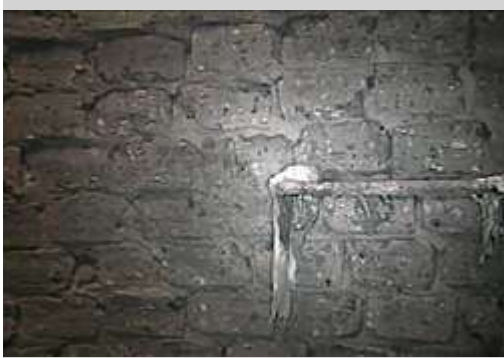
Evidence of surcharge

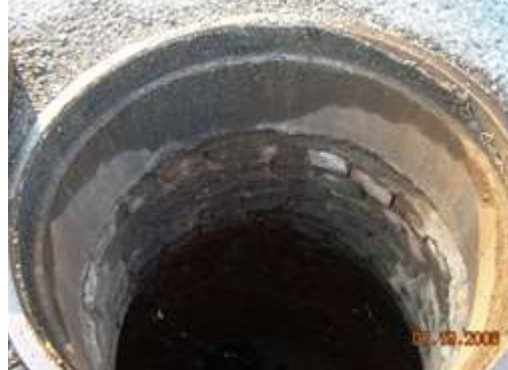
Defect

Frame leaks. Adjustment deterioration,
loose brick and infiltration.

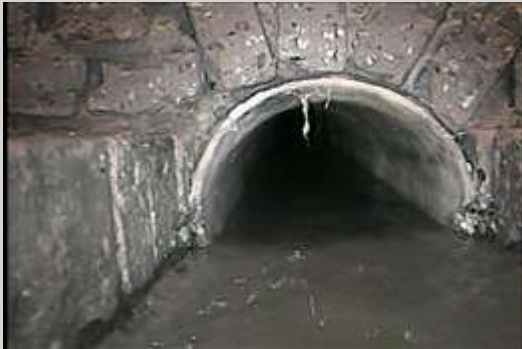
8 in. Circular Gravity Sewer Pipe Out @ 12 O'Clock

Infiltration: **Evidence** Pipe Seal Cond: **Unknown**

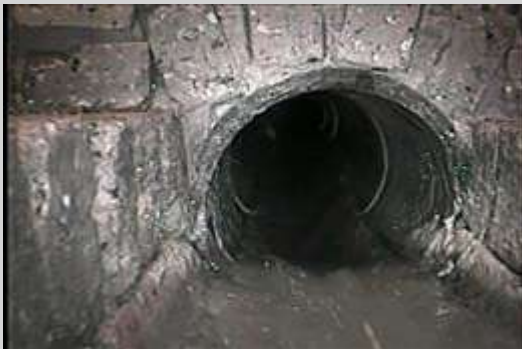
8 in. Circular Gravity Sewer Pipe In @ 6 O'Clock

Channel deterioration.

Infiltration: **Evidence** Pipe Seal Cond: **Unknown**

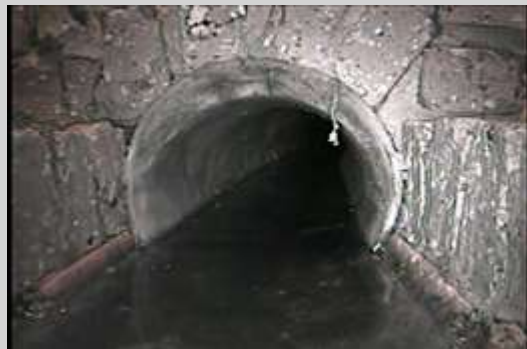
8 in. Circular Gravity Sewer

Barrel deterioration, cracks and infiltration.

Infiltration: **Evidence**

Pipe Seal Cond: **Cracked**
